Bridger Range, Ramp
Bridger Range
MT
 Elevation: **8000 ft**
 Aspect: **NE**
 Specifics: **Ski tracks on slope; We skied slope**

Spencer Jonas
Sat Nov 11 14:45 2017
 Co-ord: **45.82853N, -110.93153W**
 Slope Angle:
 Wind Loading:

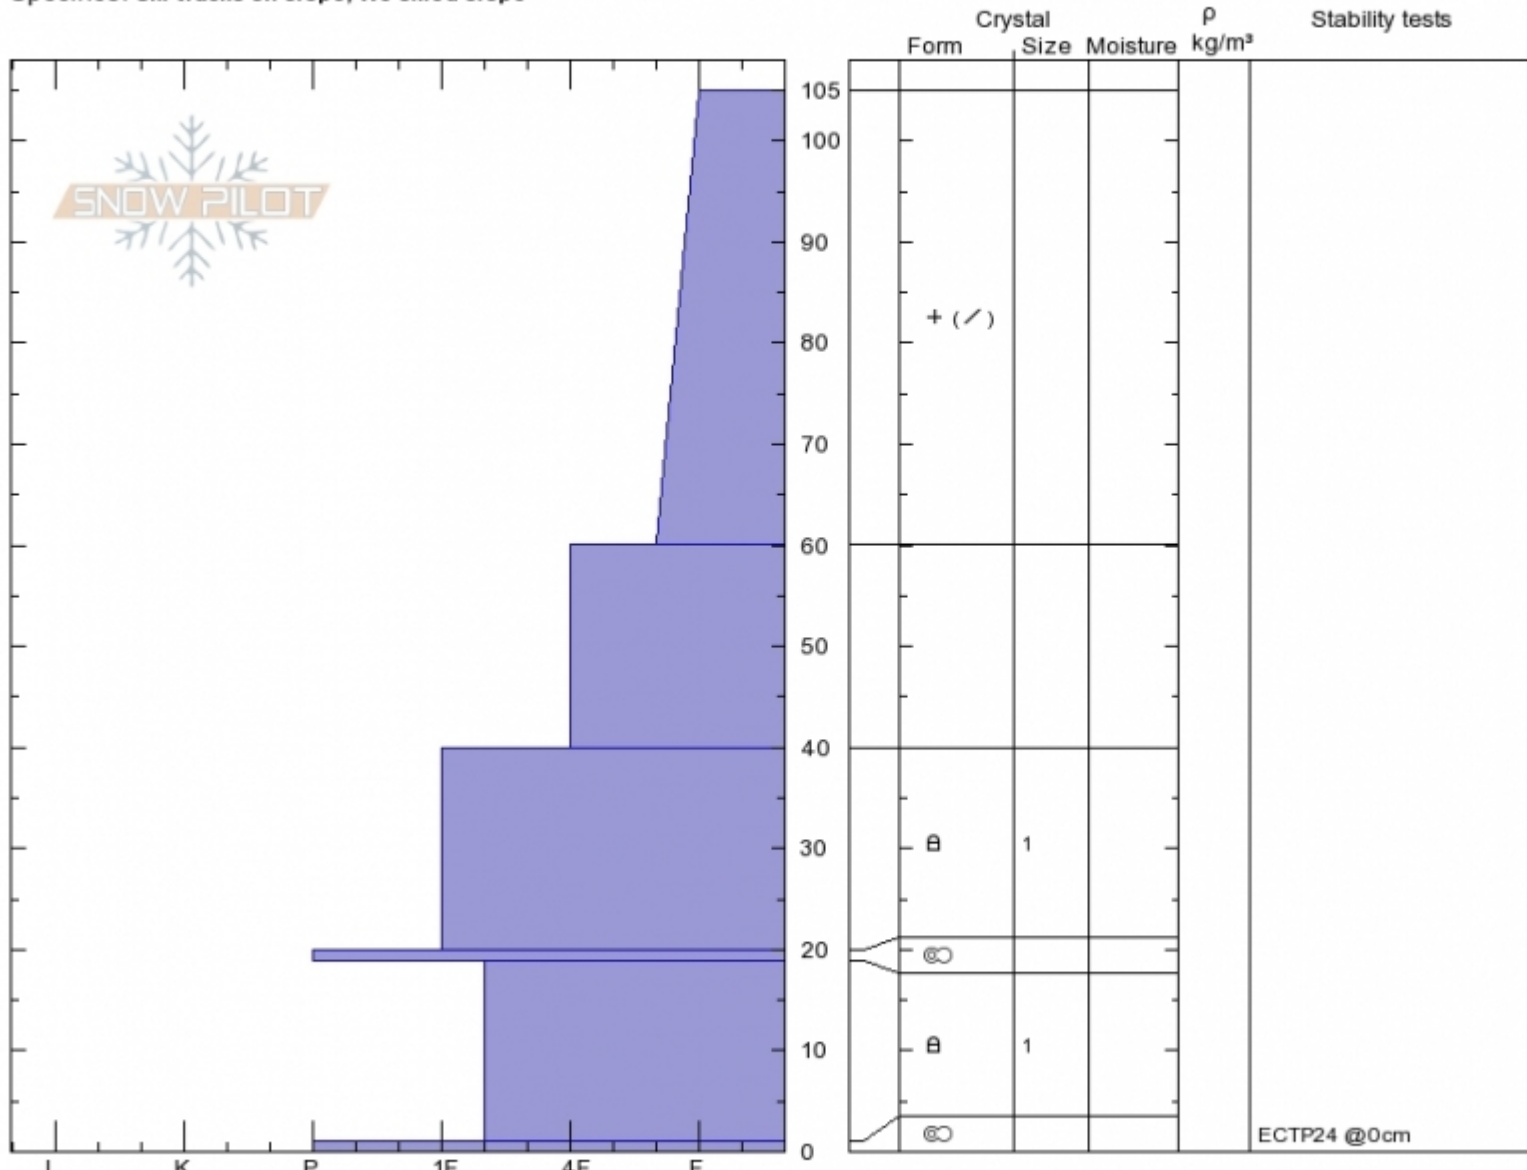
Notes: There was an air pocket between the ice crust that formed the bottom layer and the ground. The column failed when the ice broke a little ground that it was attached to, a small root and rock at the back of the column. Our layer of concern was the old September snow. There was no sign of instability at its interface. It is hard to interpret the ectp as a sign of instability, it seemed to be more an issue of ground movement specifically beneath the column and not an indicator of overall instability at the ground.
